Environmental Solutions Help Create New City Roadway

By Angelo Waters, PE, LEED AP

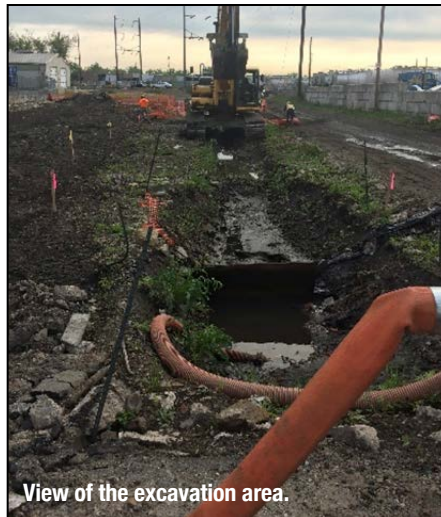
View of the excavation area.

While installing a section of subsurface drainage pipes for this project, the contractor encountered an approximately 200-linear foot section of petroleum contaminated soil and shallow groundwater in the vicinity of an abandoned underground oil/water separator. Up until the late 1980s, the area of concern was recorded as being a heat resistant brick and ceramic manufacturer. This release was reported to the Pennsylvania Department of Environmental Protection (PADEP) and

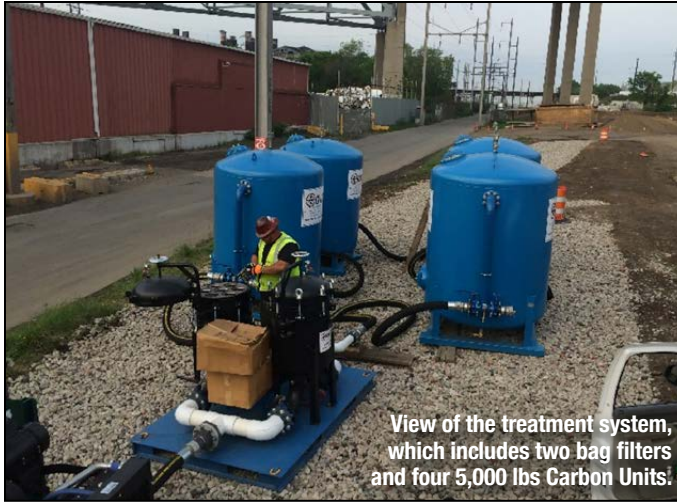
View of the treatment system, which includes two bag filters and four 5,000 lbs Carbon Units.

Since the project involved dewatering during construction of the drainage system, the contaminated groundwater and handling of the excavated soils required a unique solution; therefore, a site-specific dewatering and groundwater treatment system was designed to remove floating free residual product, sediment, and dissolved organics from the pumped groundwater prior to discharge. The trailer-mounted dewatering treatment system that was utilized during dewatering activities included two parallel 18,000-gallon weir frac tanks and two internal bag filters. It also included four 5,000-gallon carbon absorber units and a back end flow meter.

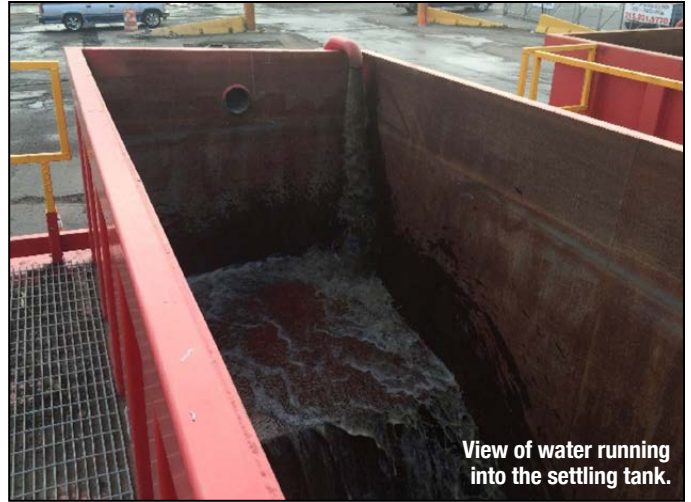
View of water running into the settling tank.
